Landslides and related features interpreted
from aerial photographs:

Photointerpretation and field check 1979-1980, 1982.

LANDSLIDES AND RELATED FEATURES OF THE JACKSBORO, TENN. QUADRANGLE by Roger E. Thomas and Alfred R. Taylor 1982 U.S. Geological Survey OPEN FILE MAP 82-653 (C-15)

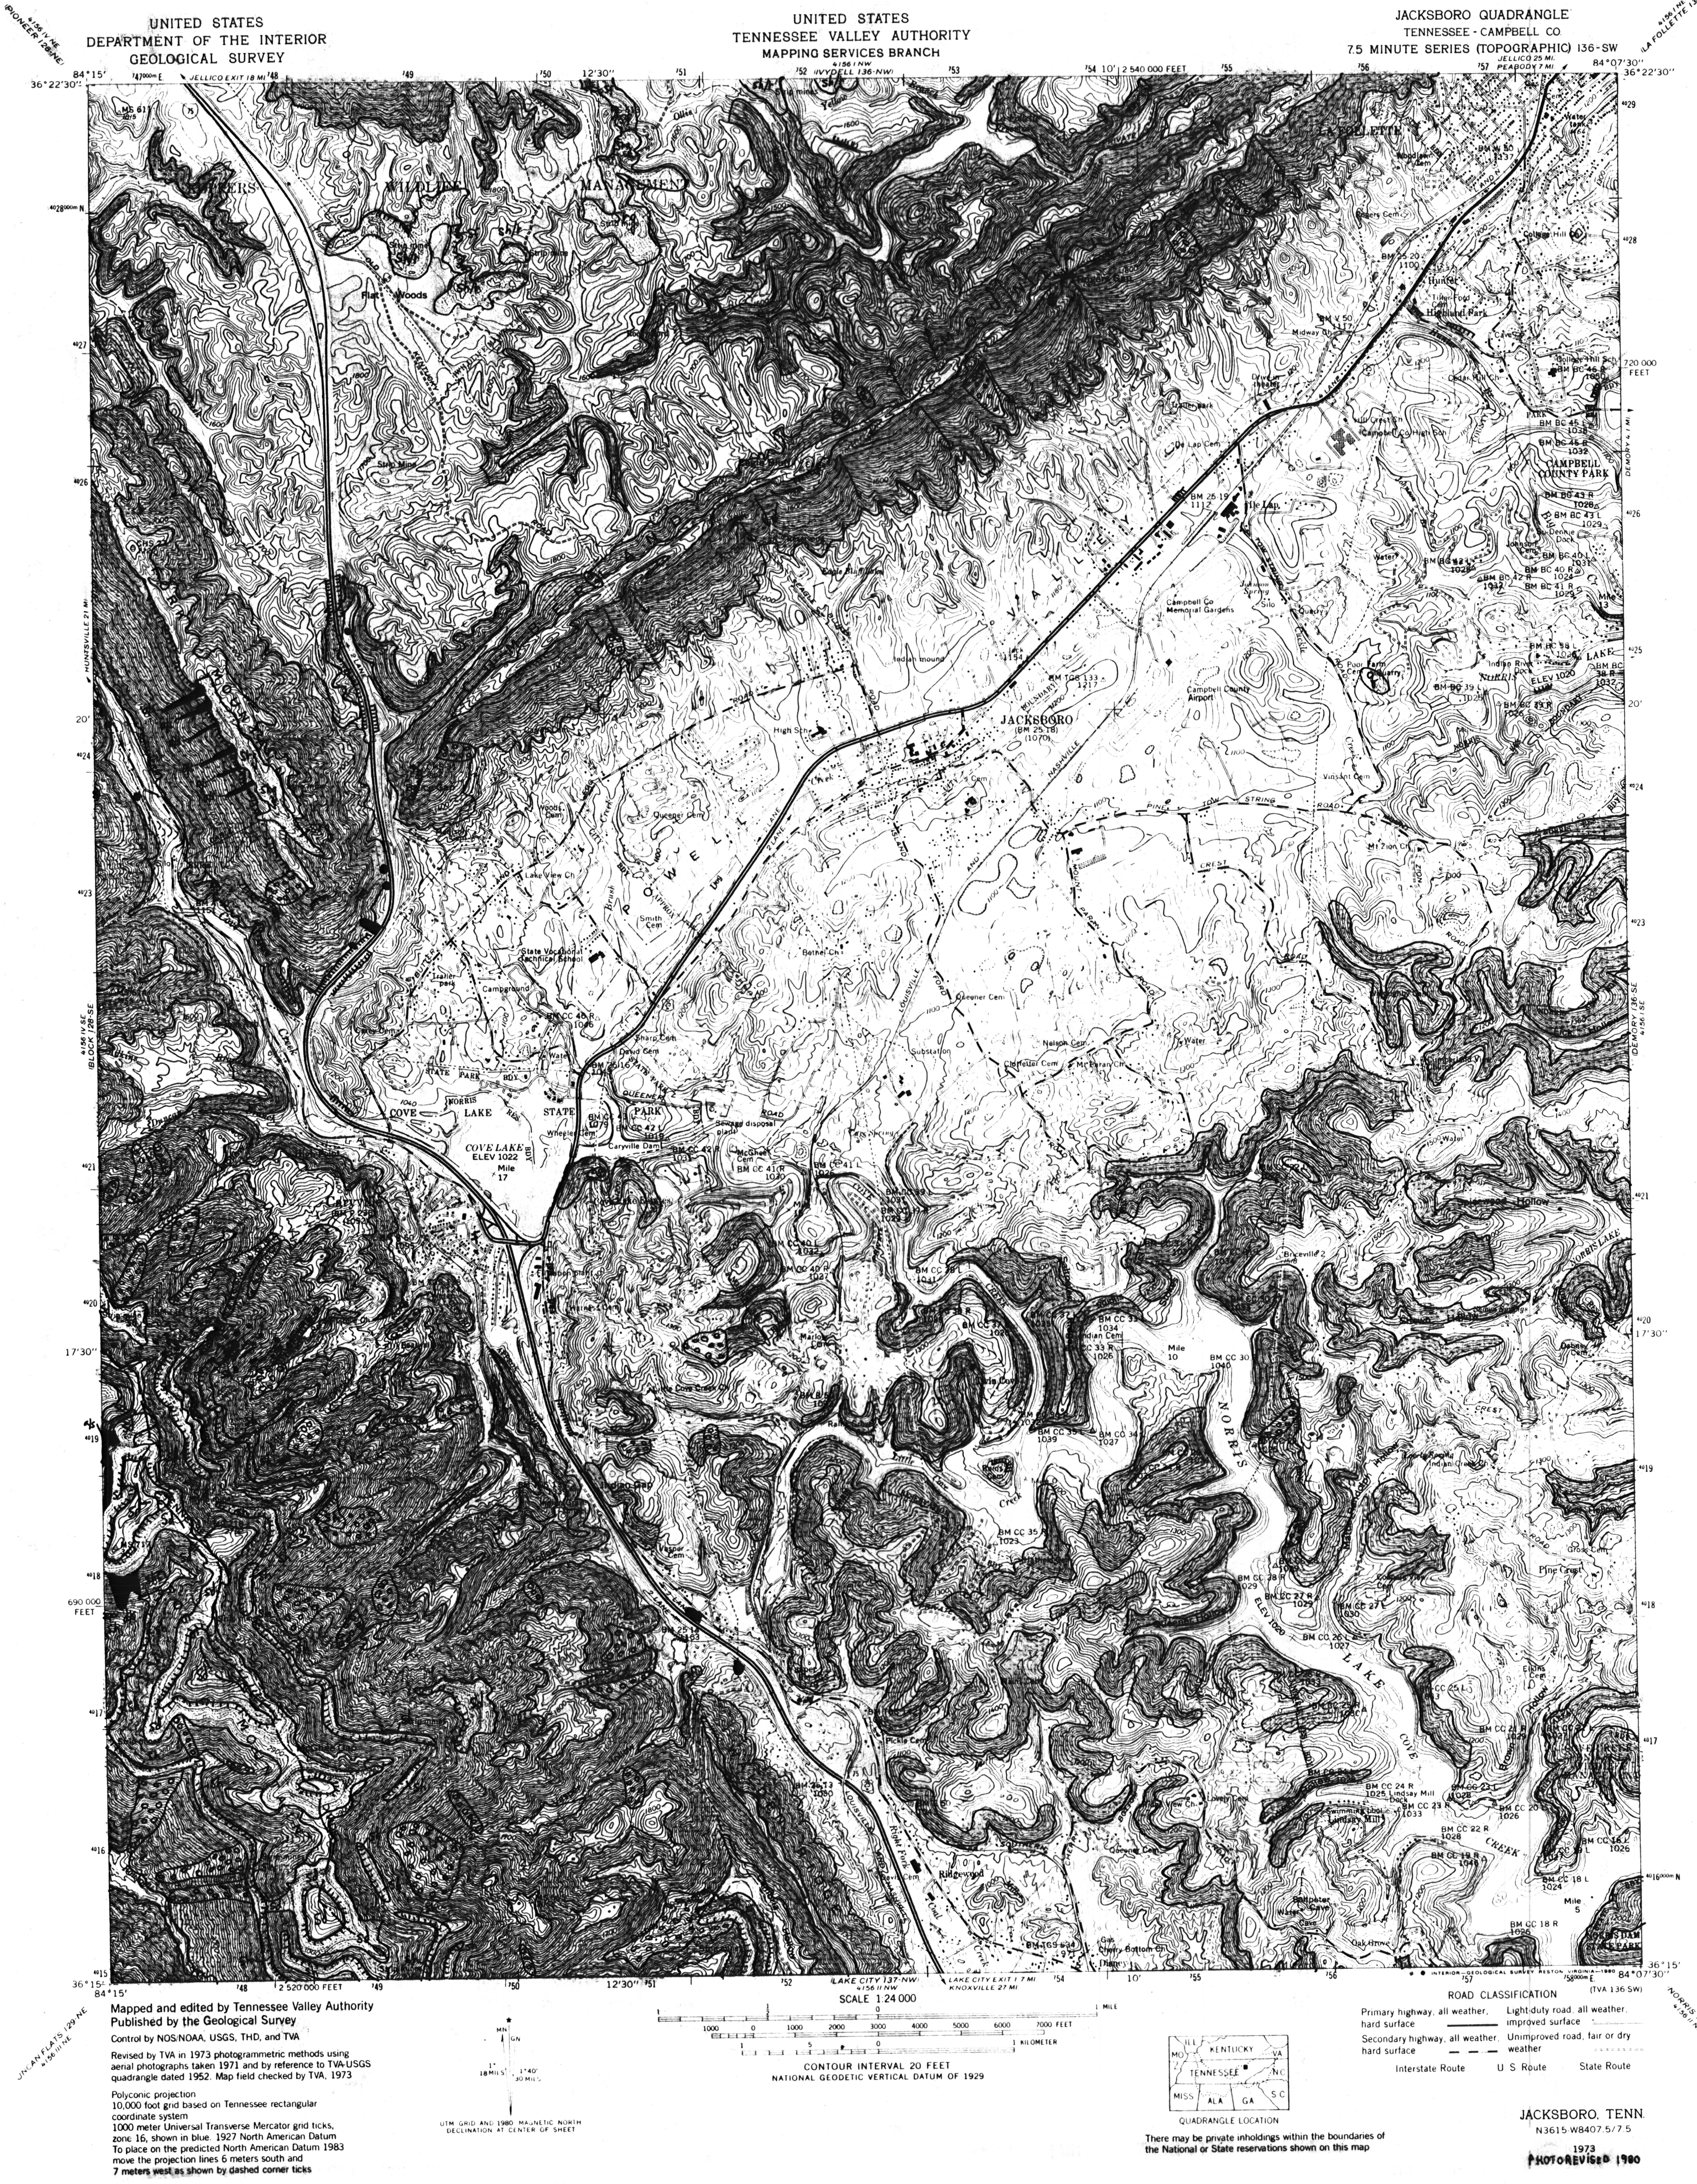
- ACTIVE OR RECENTLY ACTIVE LANDSLIDE
Complex landslide composed of earthflow, debris
slide, earth and rock slump. Identified from
historical records, and from scars, debris and
other field evidence. Ground extremely unstable;
sliding accelerated by excavation, loading and
changes in drainage conditions. May include
areas with several active slides too small to
be shown separately. Questioned where doubtful.

- OLD LANDSLIDE
Area of extensive hummocky ground caused by
earthflow and earth and rock slump. Lacks
clear evidence of active sliding. Relatively
stable in natural, undisturbed state,
generally not affected by small structures properly
sited in areas away from the edge of the toe;
can be reactivated by extensive, rapid exca-
vation, loading, and changes in ground water and
surface water conditions. Area of old landslide
probably includes recent ones not identified
from field evidence or otherwise documented.
Upslope boundary of landslide generally defined
by modified scarp, but downslope (toe) may be
gradational and not well defined. Questioned
where doubtful.

- COMBINATION LANDSLIDE
Area of recent and old slides in which
individual slides are not identified.
- COLLUVIAL SLOPE
Valley wall along major streams with slope as
steep as 40° (85%); stony, clayey silt soil up
to 50 ft. (15 m) thick; commonly buttressed by
a terrace or bench at the toe of the slope; very
susceptible to sliding by cutting of toe area,
removal of terrace or bench, and overloading;
slide commonly activated without apparent cause.

- COLLUVIAL SLOPES WITH LANDSLIDES
Landslides too small or obscure to map
individually.
- AREAS SUSCEPTIBLE TO DEBRIS FLOWS AND DEBRIS
AVALANCHES
Primarily shallow, narrow ravines and chutes with
accumulation of stony colluvium generally 10 ft.
(3 m) or less in thickness; susceptible to rapid
movement during intense rainfall. Most ravines
and chutes designated show evidence of former
debris flows and avalanches.

- AREAS SUSCEPTIBLE TO ROCKFALL
Steep, locally vertical, natural and man-made
slopes and cliffs, 15 ft. (4.5 m) or more high;
formed dominantly of sandstone, limestone, sandy
shale, mudstone and claystone. Interbedded mud-
stone, claystone and shale weather rapidly leaving
sandstone and limestone rock faces unsupported.

- SOIL AND ROCK SUSCEPTIBLE TO LANDSLIDING
Soil and rock similar to that involved in land-
slides elsewhere in map area; primarily areas
underlain by claystone, mudstone and shale
associated with other rock types. Rock weathers
rapidly on exposure forming clayey soil highly
susceptible to sliding. Includes coves (U-shaped,
shallow valleys) containing thick layers of clayey
soil that are very susceptible to sliding where
excavation breaks continuity of slope and where
overloaded by artificial fill.

- AREAS LEAST PRONE TO LANDSLIDES
Map areas in which no patterns or symbols are shown;
primarily valley floors, ridge tops and broad
benches; modification by excavation and fill may
lead to local landslides.

NOTE
Information shown is intended as a
general guide to ground conditions as of
the date of field check. Additional
landslides and rockfalls should be anticipated
in all map units. The map unit depicts
the dominant condition in the area delineated
and variations in slope stability may occur
at any point in the unit. This map is suit-
able for general planning purposes and as a
supplement to more detailed studies for site
selection. The map cannot be used as a sub-
stitute for detailed geologic and engineering
investigations to establish design and
construction criteria of specific sites.
Some symbols may not appear on this map
because the description is applicable to a
series of maps.

- MAN-MADE FEATURES
- Strip mines (combination of letter symbols
indicates complex formed of more than one
type of strip mine)
- sh bench with high wall
- sf furrowed with high wall
- sd multiple furrows and multiple benches
- ss hilltop removed
- srg reclaimed by grading
- sru reclaimed by secondary use
- sh/r regraded in part, high wall
remains
- Coal refuse banks
- r identified on aerial photographs;
not classified in field check
- rb not burnt nor on fire
- rbb burnt
- Quarries
- q quarry site
- Gravel pits
- g site of gravel pit
- Slides in man-made features
- af earth flow in fill
- a/s earth flow in strip castings
- a/r earth flow in coal refuse
